6	THE EFFECTS OF MULTIPLE WELD REPAIRS ON THE ALUMINUM-MAGNESIUM ALLOY 5083-O	
11	September 1978	12 94p
by		
10	George R. Speight, Jr.	
Thesis Advisor:		Terry R. McNelley

THE EFFECTS OF MULTIPLE WELD
REPAIRS ON THE
ALUMINUM-MAGNESIUM ALLOY 5083-0

The effects of multiple weld repairs on the aluminum-magnesium alloy 5083-0 as used in the primary self-supporting containment systems for Liquefied Natural Gas Tankships were studied. The changes experienced by the material in microstructure, mechanical properties and stress-corrosion susceptibility as a function of number of weld repairs were carefully characterized and recorded. The results of these findings are discussed from both the metallurgical and the practical engineering standpoint.

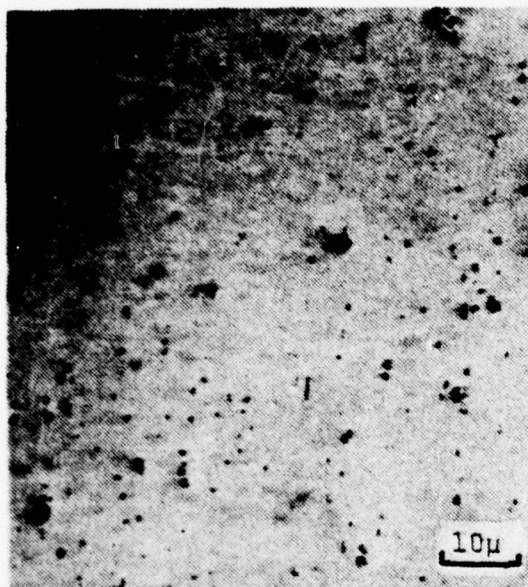
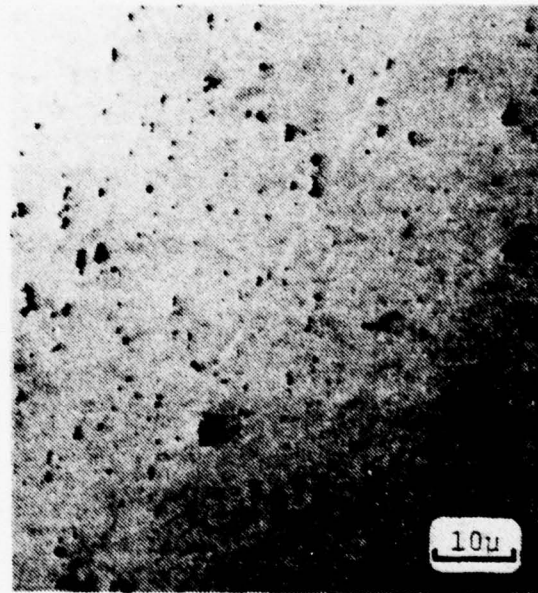
Figure 18. Photomicrographs taken of the "as-polished" specimen subjected to 8 repair simulations. The locations represented are the interface (a), approximately 6 mm (b), 18 mm (c) and 27 mm (d) from the interface. (100X)

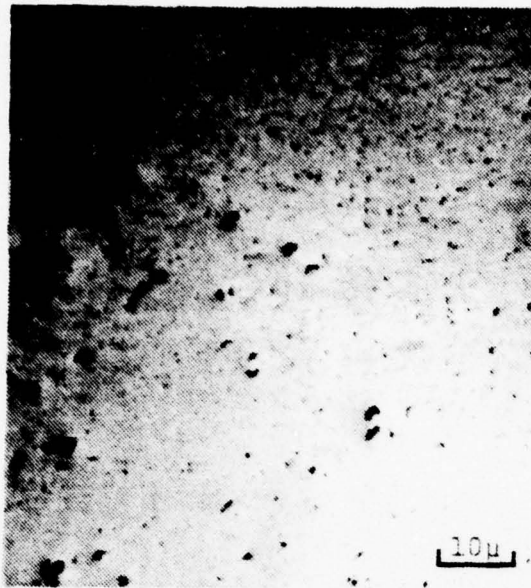
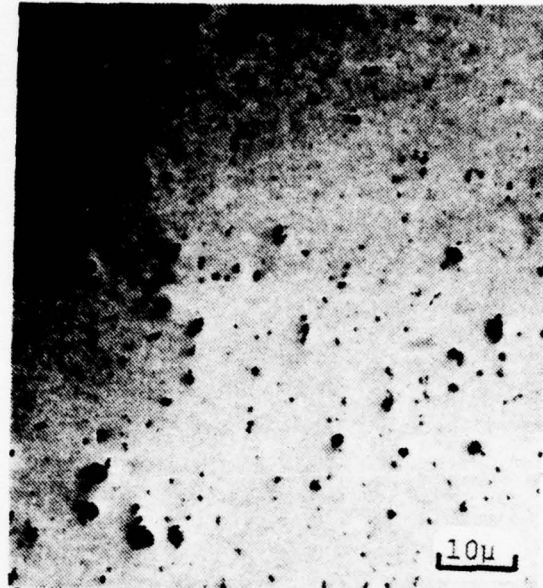
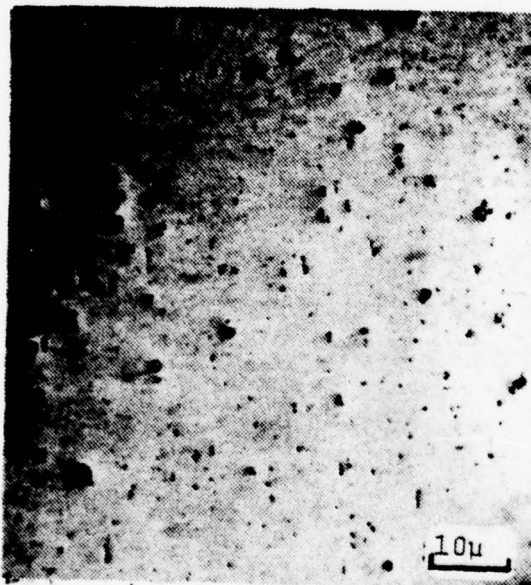
20. Photomicrographs taken of the "as-polished" specimen subjected to 16 repair simulations. The locations represented are the interface (a), approximately 6 mm (b), 18 mm (c) and 27 mm (d) from the interface.--59

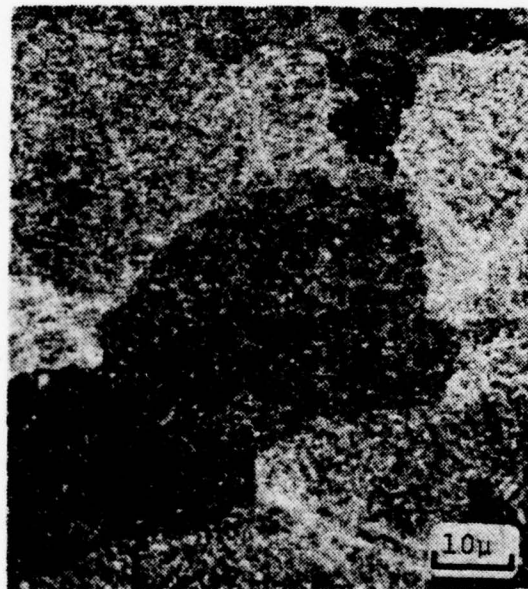
Figure 21. Photomicrographs in the etched condition of the specimens subjected to the original two-pass weld only (a), 8 (b) and 16 (c) repair simulations. The area represented in each of these micrographs is the "as-cast" weld metal. (100X, etchant: modified #12)

Figure 21 shows micrographs in the etched condition of the "as-cast" weld metal of specimens subjected to the original

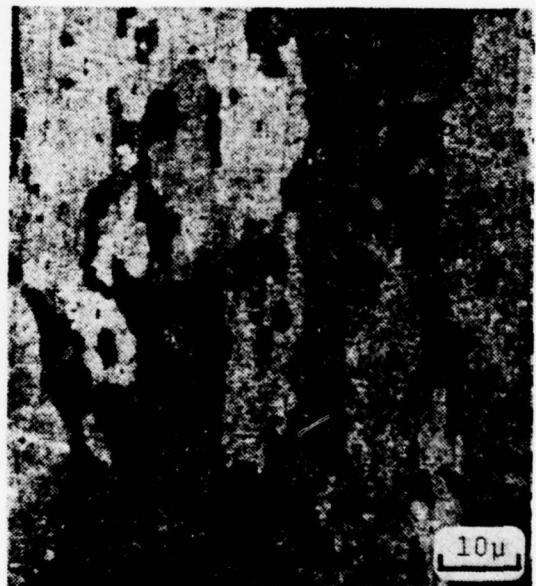
Figure 25. Photomicrographs taken of the etched specimen subjected to 12 repair simulations. The locations represented are the interface (a) and approximately 6 mm (b), 18 mm (c) and 27 mm (d) from the interface. (100X, etchant: modified #12)
